COILSAFE™ COIL COATING

CoilSafe™ coating formulation is an antimicrobial siloxane coating to protect HVAC coils and equipment from corrosive elements. Protect your coils and keep clean and healthy coil surfaces.

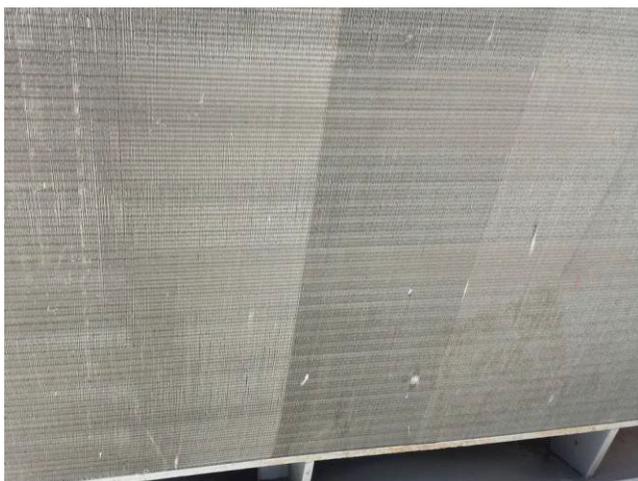
This photo depicts a commercial cooling coil of an HVAC unit on a pier, sitting directly over salt water, running for 3 years.

Typical coil life in this area is 3 years or less due to corrosion.

With **CoilSafe™** COIL COATING, the customer will experience a full extended coil life and maintain factory energy efficiency rating much longer.
